NAVAL AIR PROPULSION TEST CENTER

NAPTC-AED-1869

ROTOR BURST PROTECTION PROGRAM
INITIAL TEST RESULTS

PHASE IV - FINAL REPORT
PROBLEM ASSIGNMENT NASA DPR R-105

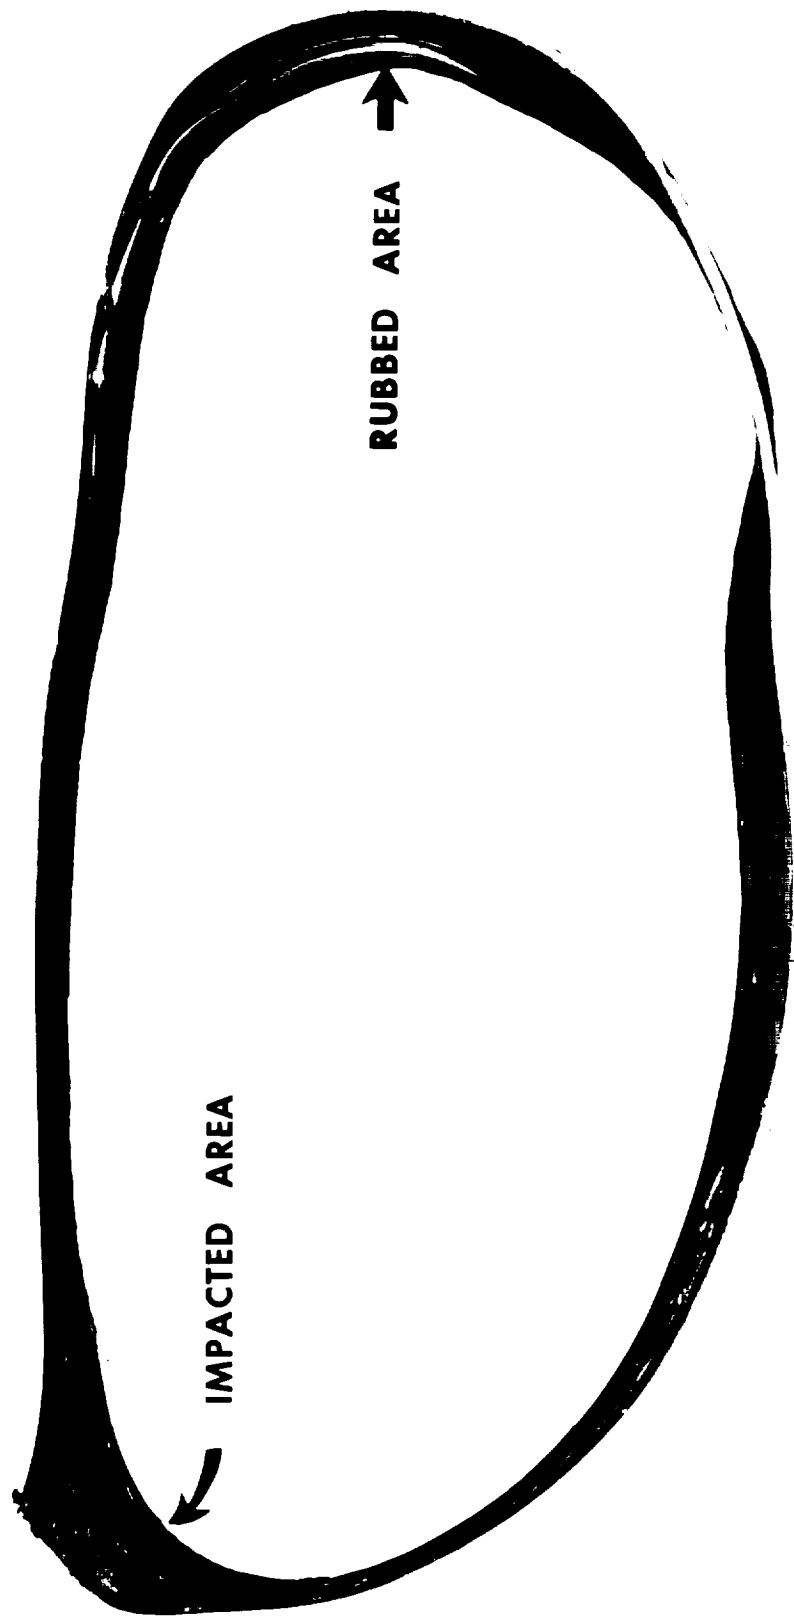
POST-TEST NO. 10
CONTAINMENT RING-RUBBED AREA DETAIL

59. The post-test photograph of the containment ring of test No. 10 is shown in plate 19. The ring area that experienced the blade rubbing is shown on the right of the photo; the impacted area is on the left side. Plates 20 and 21 show, in detail, the total damage to the rubbed area and impacted area, respectively, of the ring.

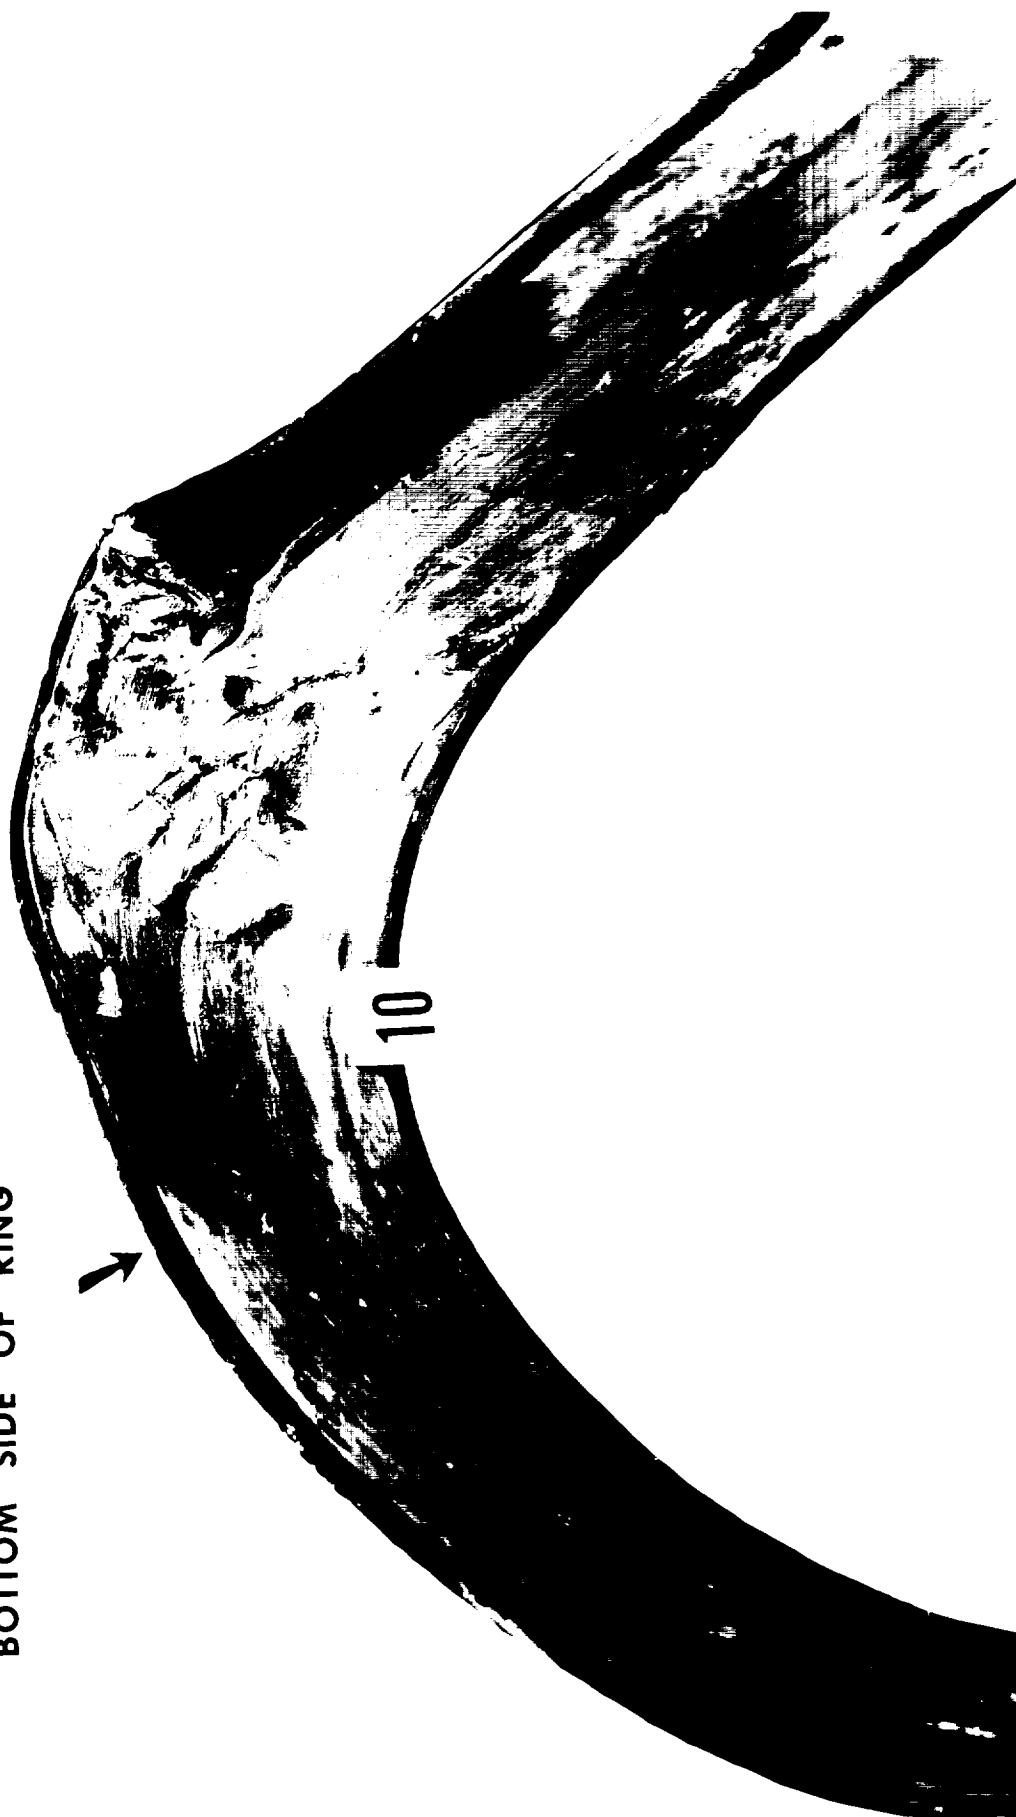
POST-TEST NO. 7
CONTAINMENT RING

60. A four-single blade burst, similar to test No. 10 was performed within a steel ring during test No. 7. High speed photographs were not obtained from test No. 7 and therefore it can only be assumed that the No. 7 blade failure was similar to No. 10. Plate 22 indicates the amount of total distortion experienced by the No. 7 containment ring. Comparing this post-test photograph with plate 19, a large difference in ring distortion can be seen. Two major parameters contributing to this difference are probably ring thickness and radial blade clearance. The ring from test No. 7 was twice as thick (0.250 inches vs. 0.125 inches) as the No. 10 ring; and the No. 7 test had a smaller radial clearance (0.475 inches vs. 0.6875 inches) than the No. 10 test.

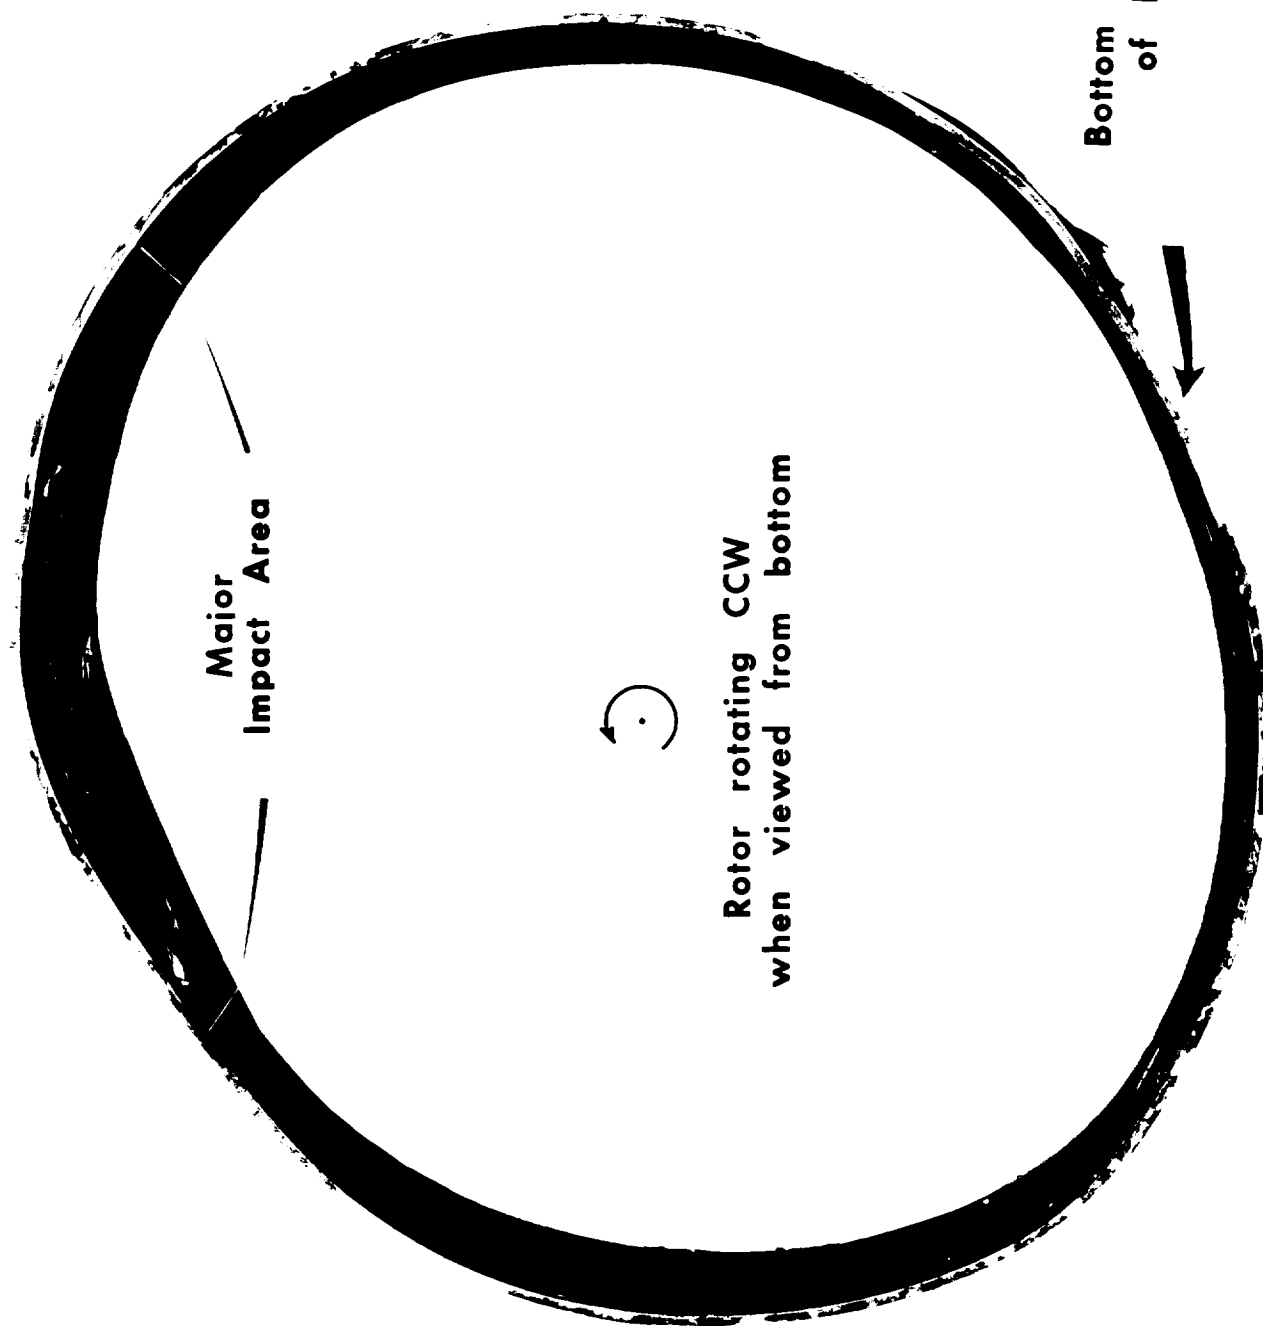
POST-TEST NO. 11 CONTAINMENT RING

63. A post-test photograph of the containment ring from Test No. 11 is shown in plate 24. The area at the top of this photograph experienced the most damage. It is a very difficult task to determine what fragment caused what indentation or gouge mark. Plate 25 is a close-up of this damaged area. The direction of rotation is clockwise when viewing plate 25; i.e., the fragments moved from left to right. Many of the blades experienced a large amount of damage and it cannot be definitely determined whether they were damaged by their interaction with the containment ring or the spin chamber floor after the failure. What can be determined by matching fragment shapes to ring indentations is that gouge "A" on plate 25 was made by the section of the blade that had been reduced in the platform section; i.e., the blade was rotated around so as to strike with its base section. Impact area "B" was caused by the striking of the convex side of a blade against the ring. Impact area "C" was apparently caused by the impact of the flat side of the blade platform section.

64. The airfoil section of all the failed blades were bend over approximately 180° so as to form a "curled" tip.

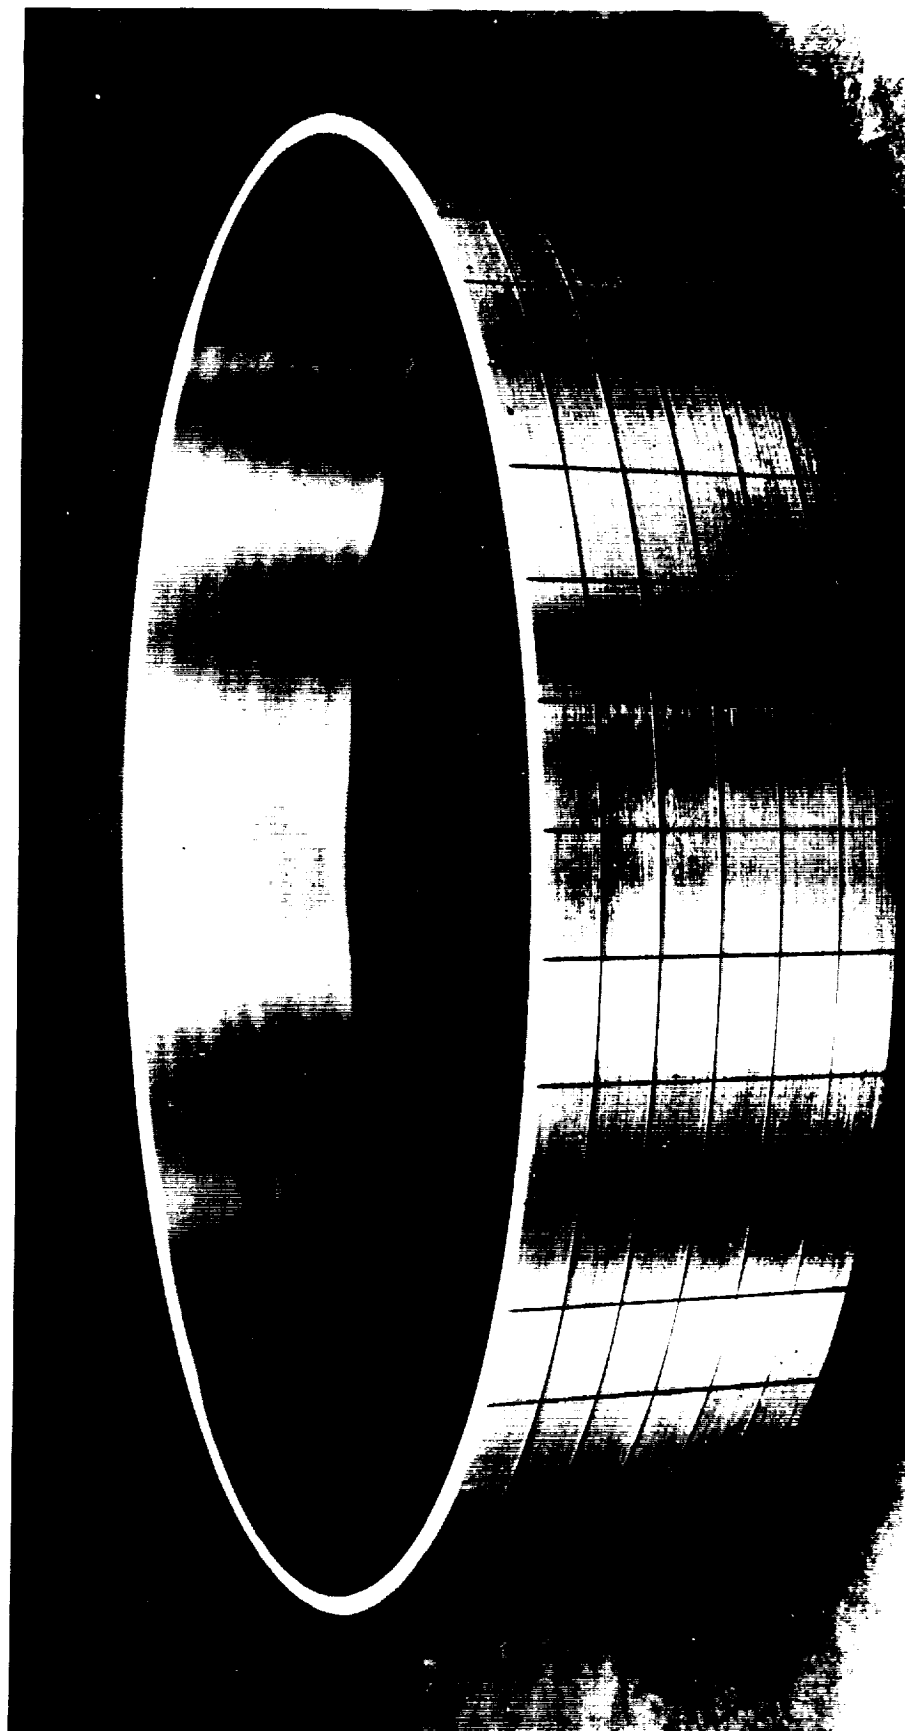
TEST NO. 6 CONTAINMENT RING

85. An interesting aspect of test No. 6 was the affect of stress concentrations on the behavior of impacted containment rings. Plate 40 shows the 0.010 scribe marks placed on the outer surface of the ring. This grid system was established to assist in the determination of plastic deformation of the ring. A post-test photograph of the containment ring is shown in plate 32. The fracture of the ring in the areas struck by fragments A and B occurred along the longitudinal grid marks (plates 41 and 42, respectively). The partial cracking in the larger segment of the containment ring (plate 43) occurred parallel to one of the longitudinal scribe marks.

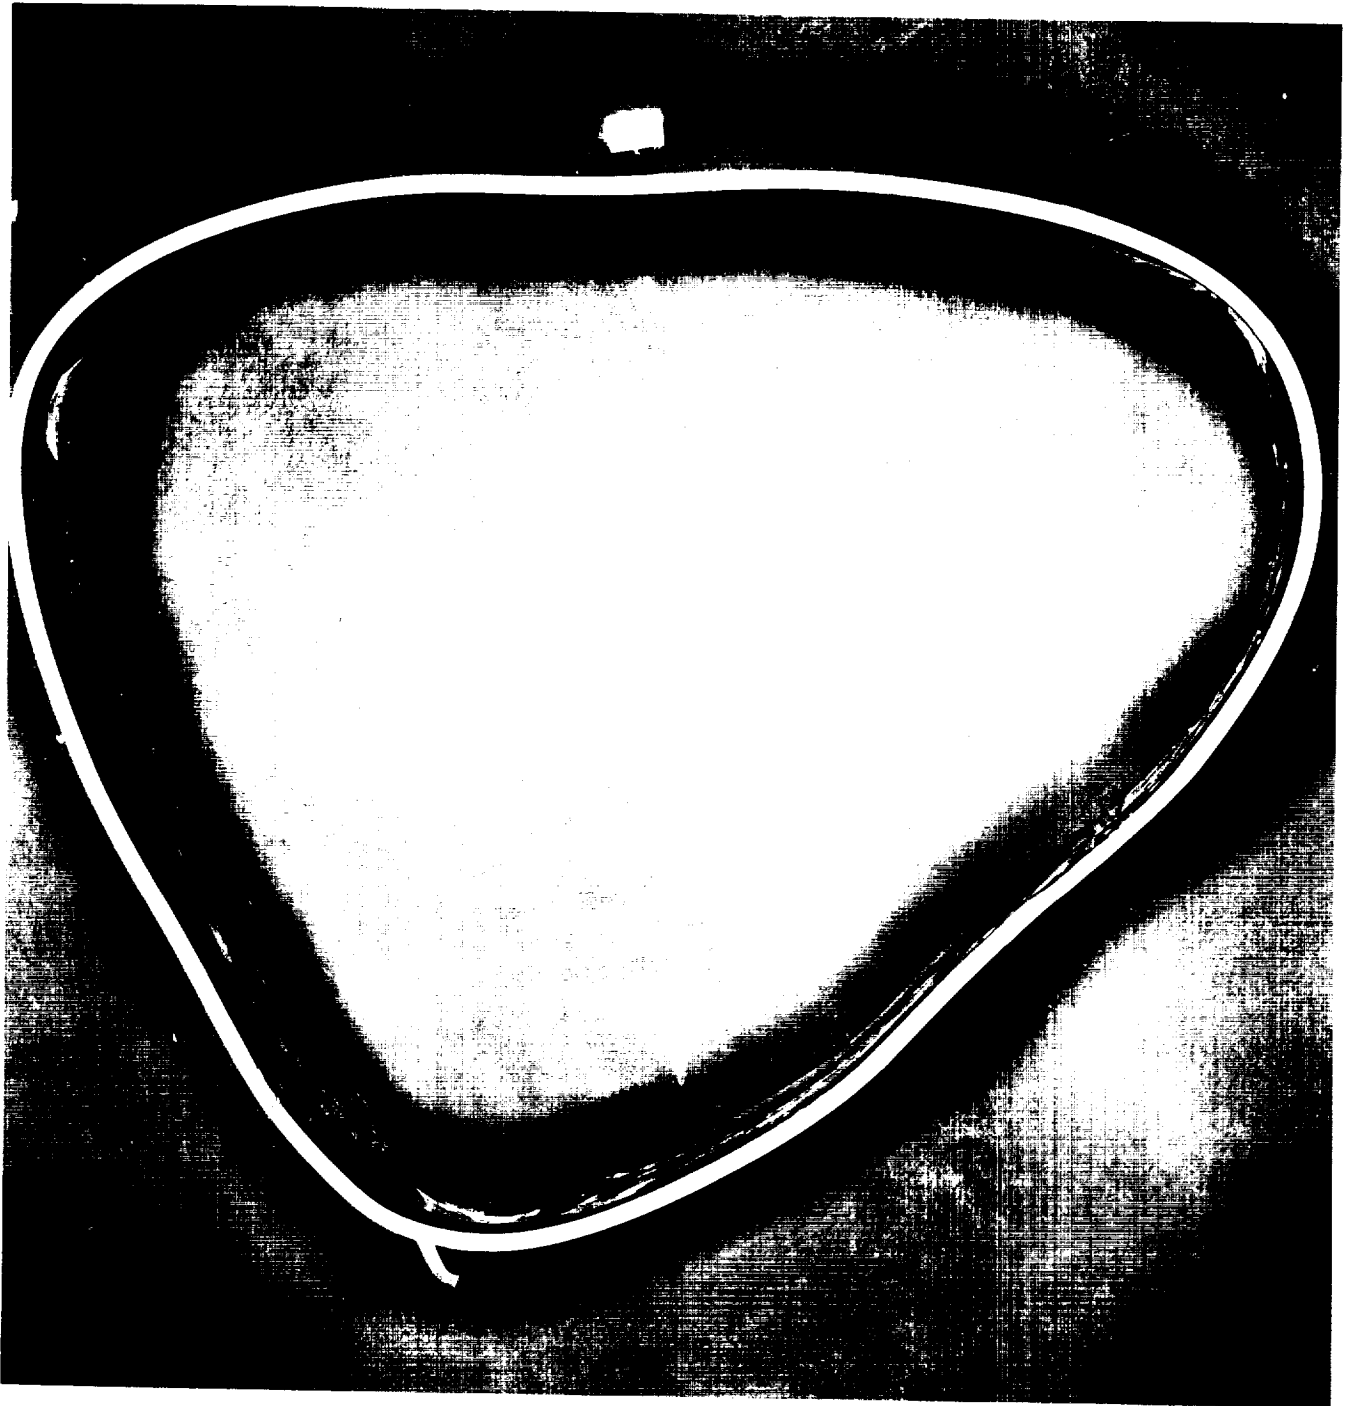
POST-TEST NO. 5 CONTAINMENT RING

87. A similar tri-hub burst was produced at a slightly higher speed than test No. 6 (13800 rpm vs. 12750 rpm). The containment ring for test No. 5 was 0.024 inches (0.252 vs. 0.228) thicker than the ring for test No. 6. The three annular sector fragments from test No. 5 apparently struck the ring simultaneously and at points equidistant around the inner circumference (plate 44). Two of the fragments left imprints in the ring but did not crack or penetrate the ring. The third fragment partially sheared a plug from the ring. Plate 45 details this plugged section still attached to the ring. This plugging action is very similar to that produced by fragment C of test No. 6.
